Characteristics of July 2019 Cherna Mesta River flash flood

One of the biggest rivers in the southern part of the Balkan peninsula – the Mesta River is well-known for frequent flash floods, especially in the upper river course. As a result of severe storms and related heavy rain in mid-July 2019, the Cherna Mesta River flooded, and this resulted in heavy damage to the road infrastructure and water-supply systems. All data indicate that this was not a usual water flood, instead at peak flow, the river carried a huge amount of gravel. Our mapping of erosional and depositional features related to the 2019 event, as well as geomorphological analysis, allows for distinguishing distinct sectors along the river valley. Most hazards are defined in the lower reaches of the Cherna Mesta River, where the processes of channel aggradation and lateral erosion are pronounced. The field analysis of the flood-related deposits indicates the operation of debris flood and hyperconcentrated and water flood processes.

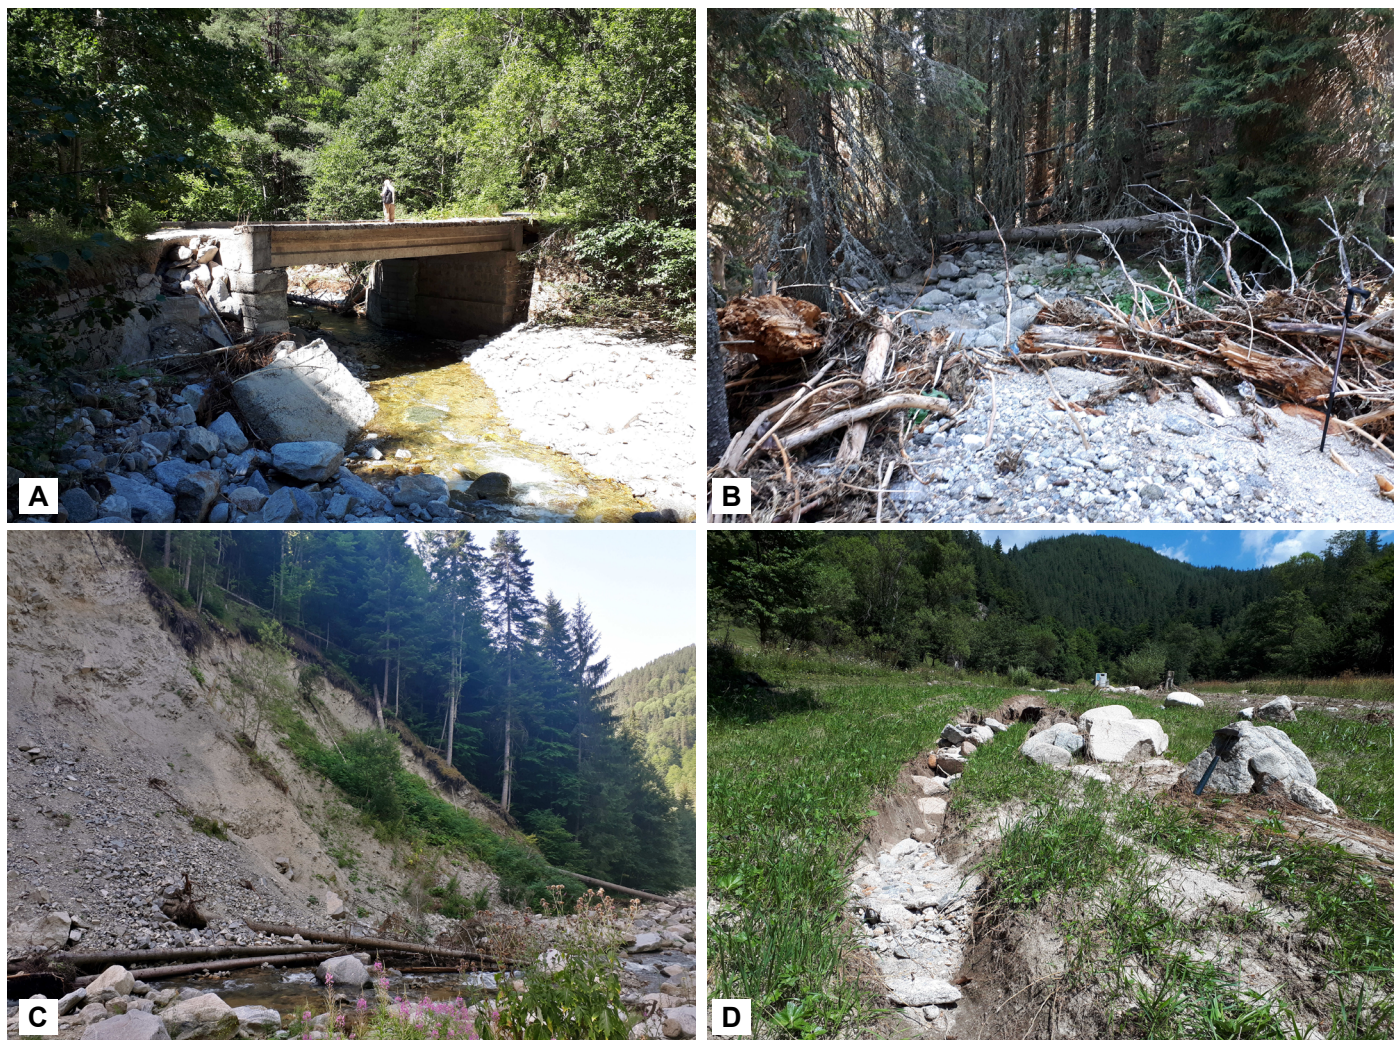
Figure 2. Examples of the damages and geomorphological features related to the mid-July 2019 flood. **A** Damages on the bridge above the powerplant water catchment. In the foreground, a large concrete chunk is visible, part of reinforcements next to the bridge. The photo was taken in August 2019. **B** Broken logjam with fresh deposition around. The photo was taken in September 2019. **C** Active water erosion and slope collapse. The photo was taken in August 2021. **D** Flash flood wave attempted to straighten the river course and scoured a new channel in the meadow, part of the flood plain. The flood-related deposition is represented mainly by sand sheets, yet boulder-sized clasts are also present. The photo was taken in August 2019 to the west of the main channel, looking N, upstream.

For the **Mixed sector** is typical the wider valley floor reaches up to 20–30 m in width. The braided nature of the river starts to be obvious, yet still not detectable from the detailed topographic maps and satellite imagery. Erosional processes seem to dominate, as the river channels are often incised in bedrock or older alluvium deposits. A typical feature for this part is dams/jams created by large wood trunks. Such logjams are blocking either the entire channel system or a single channel (Fig. 2B). The areas behind them act as sediment traps.

above the powerplant water catchment, the side slopes expose strongly cataclastically reworked and weathered granite. The active river channel is eroding the toe of these slopes even in cases of low flow, thus causing instability and slope collapse (Fig. 2C). Sediment entrainment within this sector was an important contributor to flows with different sediment-to-water ratios that occurred down the river course. Importantly, increased sediment pulses into the river system strongly favour its widening, increase banks instability, and often lead to avulsion. All these features are documented in relation to the 2019 event in the lower parts of this sector and also in the Alluvial plain sector where huge amounts of sediments were

The Alluvial plain sector is defined below the 1 100 m a.s.l. where the valley widens significantly, channels are not laterally confined and there is a drastic reduction in the river slope. The width of the flood plain is increasing downstream from 100 m next to the powerplant to 150 m next to the village. There is no bedrock, and the valley floor is completely covered by alluvium. Typically, there are one active and 2 to 4 inactive channels. Here the erosional processes are of limited significance and only minor bank erosion, soil and alluvium erosion at the places of new channels are observed (Fig. 2D). Despite the lower slope, during flood events, the water flow is capable to transport even coarse sediments (up to small boulders), and this is evident from the studies of the recent alluvium below the village Cherna Mesta. In general, the river course is straight, yet at a decameter scale, the river channels are slightly sinuous. During the mid-2019 flash flood, there were numerous attempts to straighten the river course: new channels formed where floodwaters followed the most direct path downstream. In case when the water force was enough, the channel bends are cut across by a newly formed channel (chutes). In other cases, the river overtopped the banks at the bends, depositing sheets of cobbles and sand on the immediate floodplain (Fig. 2D).

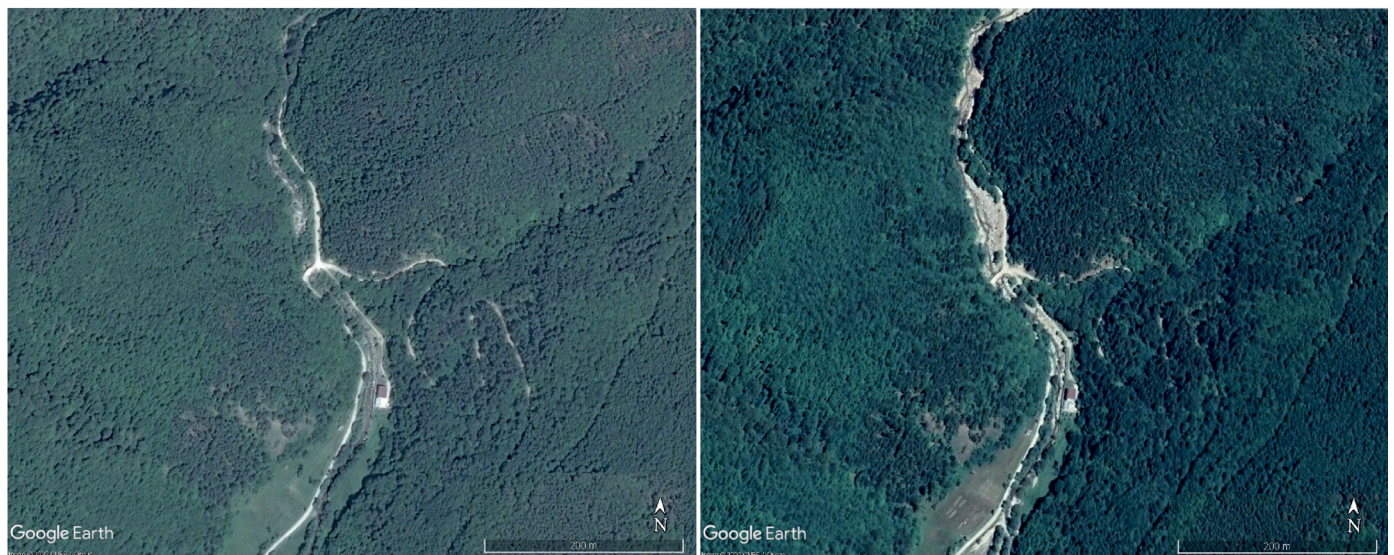
Figure 3. Formation of new river channels at the expense of the flood plain and newly formed cobble-boulder accumulations during mid 2019 flash flood event. Location: next to the Cherna Mesta powerplant (visible on the lower central part).
